Restoring Native Fish Passage

**Remediation Work to 5 Sites in the Lower
Burdekin and Townsville Areas**

2011

Upper Sheepstation Creek (5 Ways Crossing)

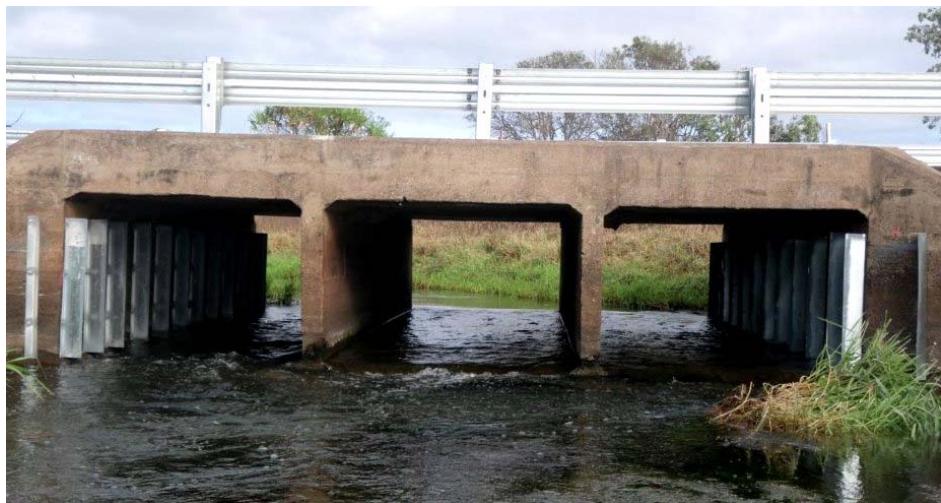
Figure 1. Baffles dyna bolted to the two outside walls of the culverts.

BAR116 on Sheepstation Creek (5 Ways Crossing) was constructed as per the concept design in the 'Burdekin Fishway's Summary Report 2010-11'. Steel baffles were dyna bolted to the two outside walls of the culvert barrels (figure 1). The baffles were spaced 600 mm apart; accept for the last meter, where the baffles were spaced 300 mm apart. The rock-ramp fishway consisted of 3 ridges constructed out of large 1 m sized rock specifically placed into position via a 21 tonne excavator (figure 2). This was secured and locked into place by large 1.3 m size armour rock placed at the 'toe' of the fishway and 300 - 800 mm sized rock used to form the walls and stabilise the banks. The drops between pools in the fishway ranged between 50-80 mm, providing suitable conditions for lowland fish communities of the greater Burdekin region. For full fishway designs please refer to pages 30-32 in appendix 1 of this report.

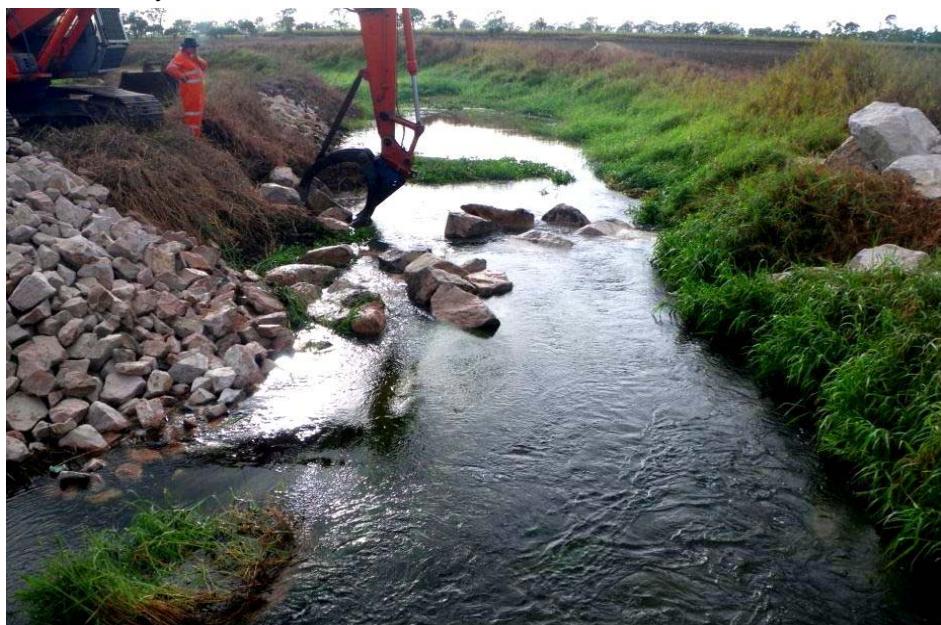
Figure 2. Excavator placing 1 m size rock to form the bottom ridge of the fishway.

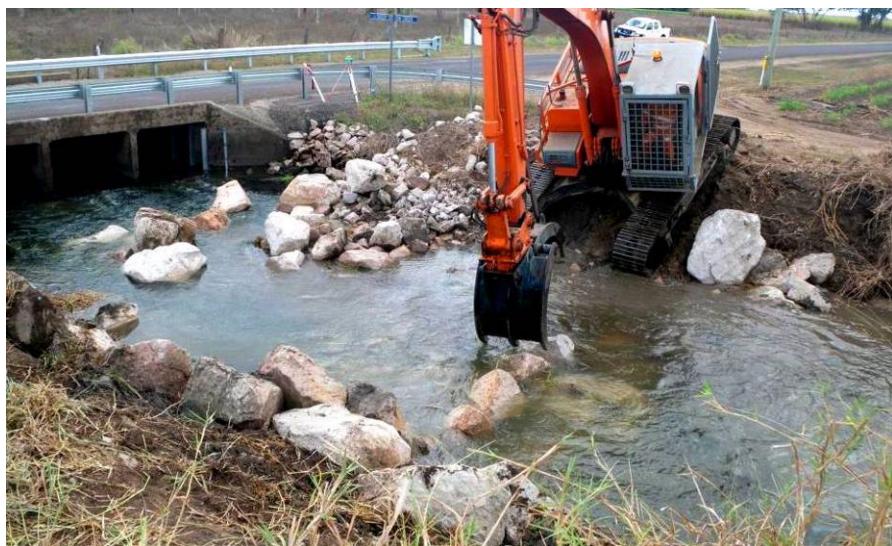
Figure 3. Excavator placing 1 m size rock to form the bottom ridge of the fishway.

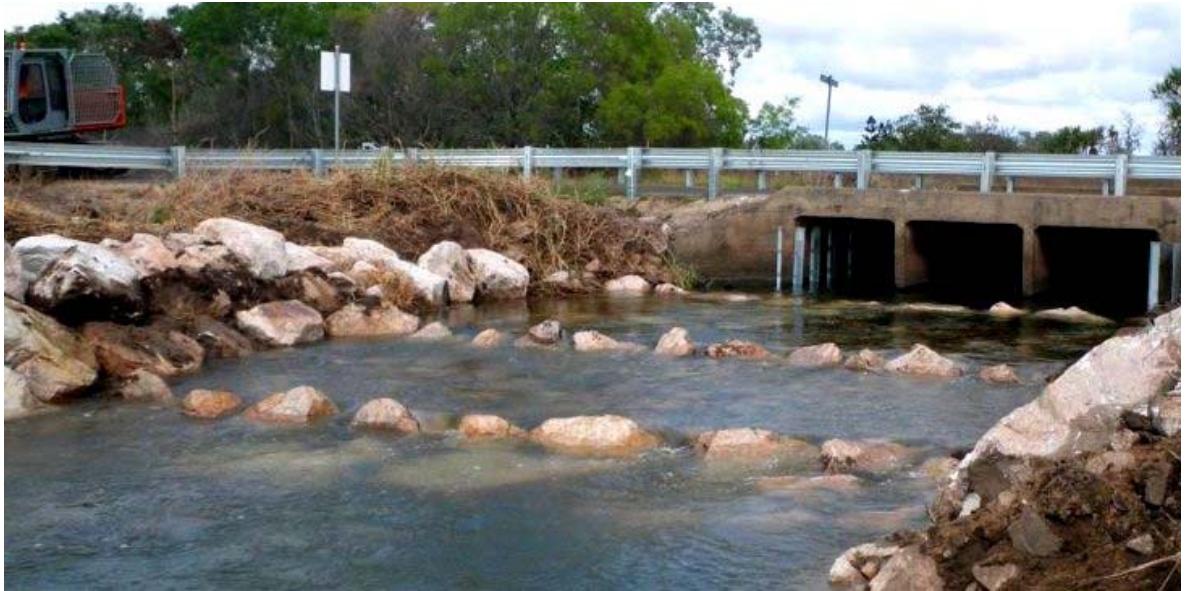
Figure 4. Finished rock-ramp fishway. Photo taken downstream of the entrance to the fishway.

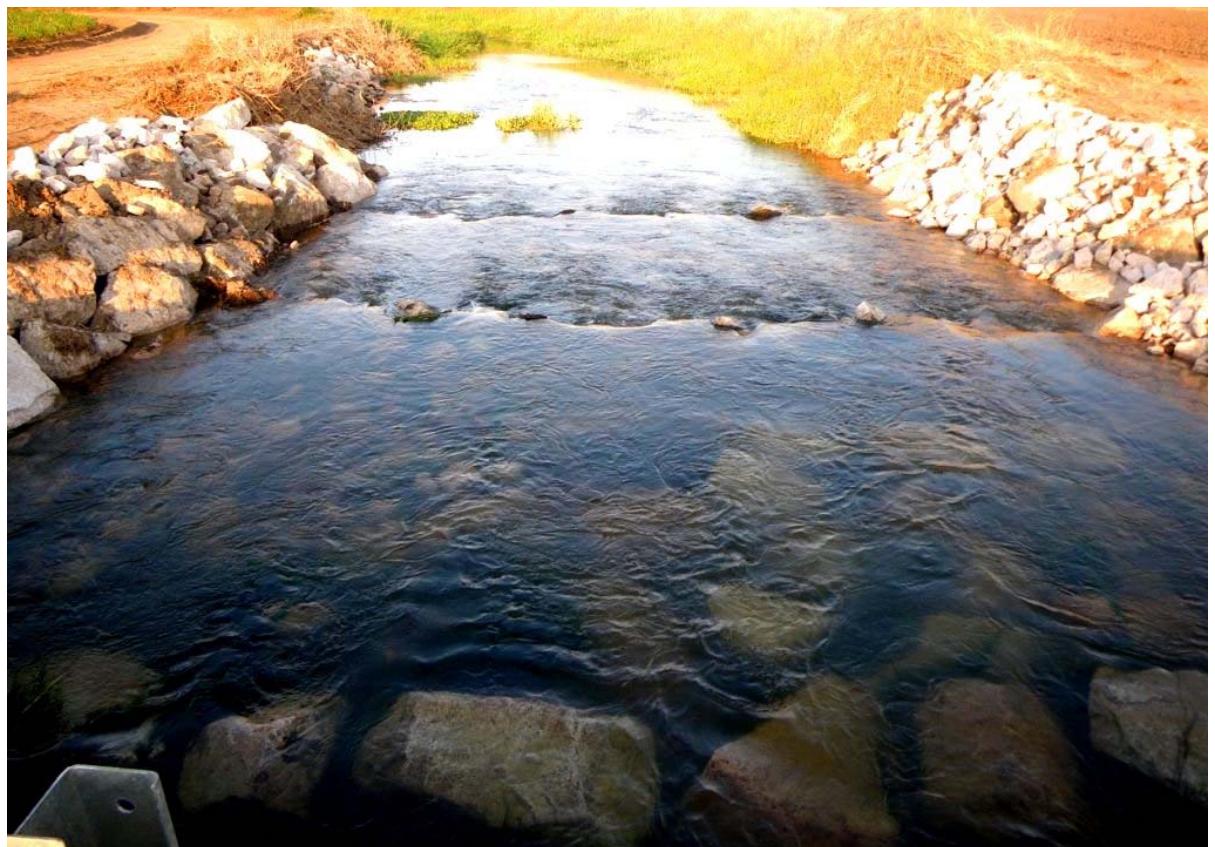
Figure 5. Top view of the finished rock-ramp fishway on Sheepstation Creek.

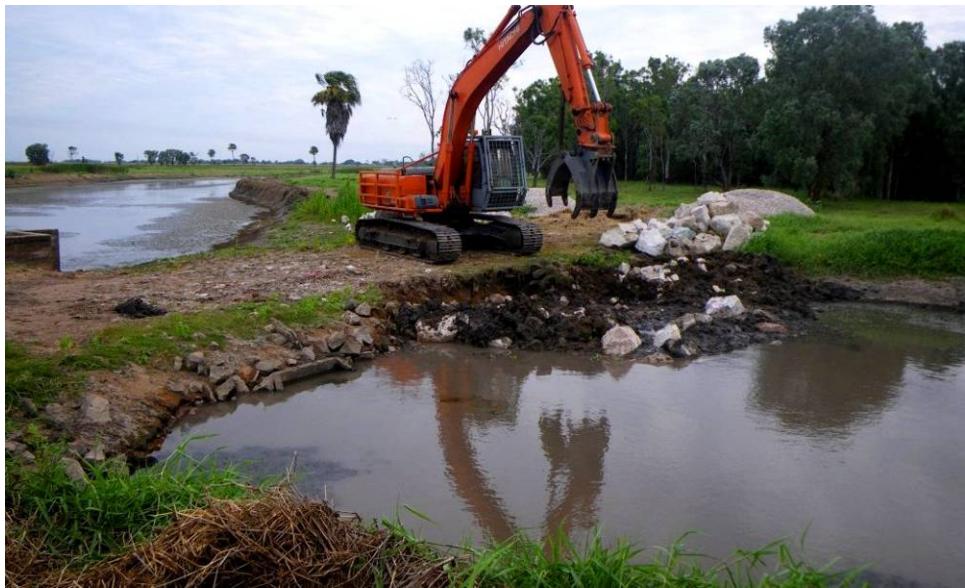
Figure 6. Excavator constructing the first ridge of the fishway.

The rock-ramp fishway consisted of 3 ridges constructed out of large 800 mm size rock specifically placed into position via a 21 tonne excavator (figure 8). This was secured and locked into place by large 1 m size armour rock placed at the 'toe' of the fishway and 300 - 800 mm sized rock used to form the sides of the fishway and stabilise the banks. 40 mm ballast rock was used to surface the access road at the fishway exit. The drops between pools in the fishway ranged between 50-80 mm, providing suitable conditions for lowland fish communities of the greater Burdakin region. For full fishway designs please refer to pages 40 & 41 in appendix 1 of this report.

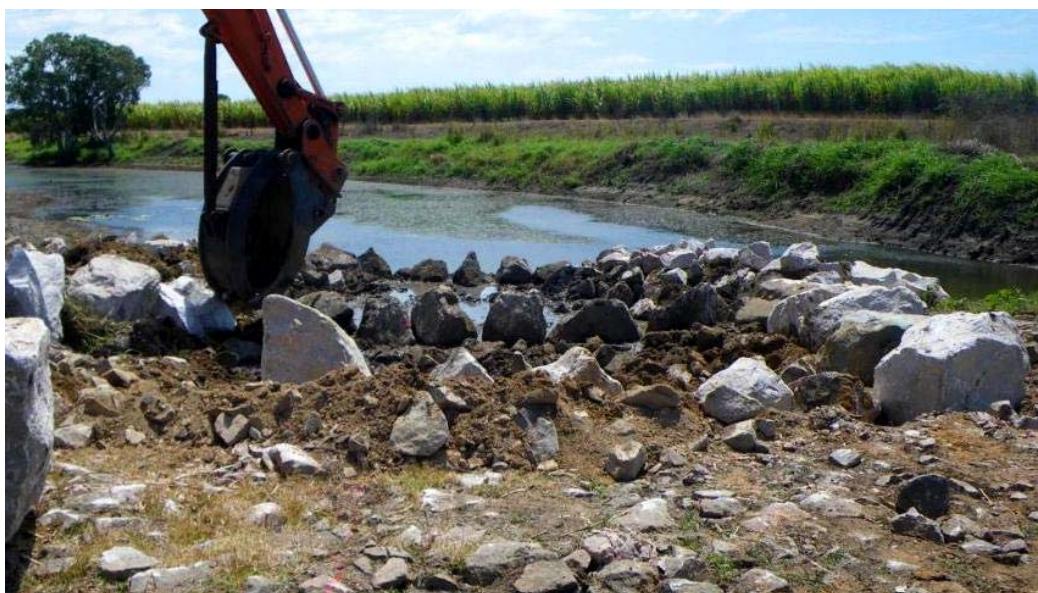
Figure 7. Excavator forming the second ridge of the fishway

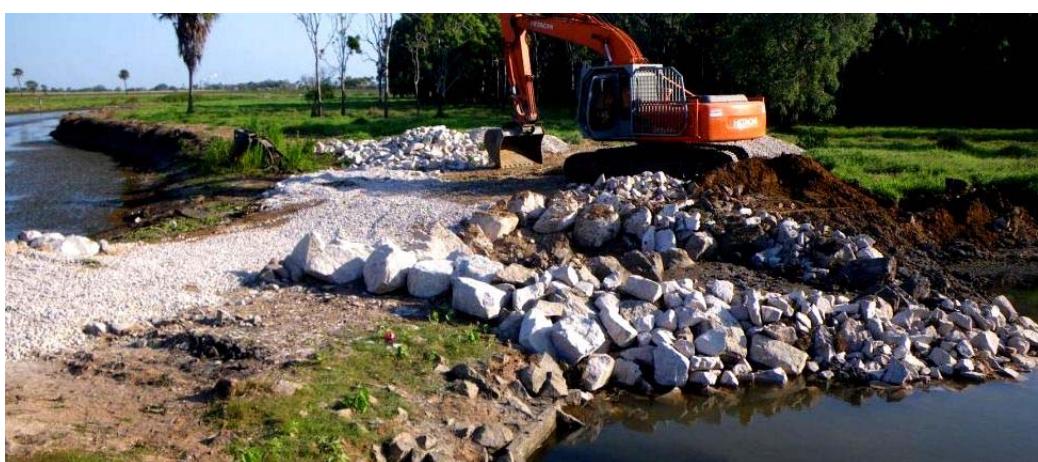
Figure 8. Excavator sealing the access road. Fishway complete.

BAR1113 on middle Sheepstation Creek (Old Crossing) was constructed as per the concept design in the 'Burdakin Fishway's Summary Report 2010-11' apart from one minor change to the access road located above the fishway exit. The access road is required for the cattle farmer to access grazing areas across Sheepstation Creek. It was originally designed to be 300 mm under water in 'normal' flow conditions. However, after consulting with the farmer on site, it was decided that the access road should be raised by 200 mm, so that the road only has 100 mm of water flowing over it under normal flow conditions.

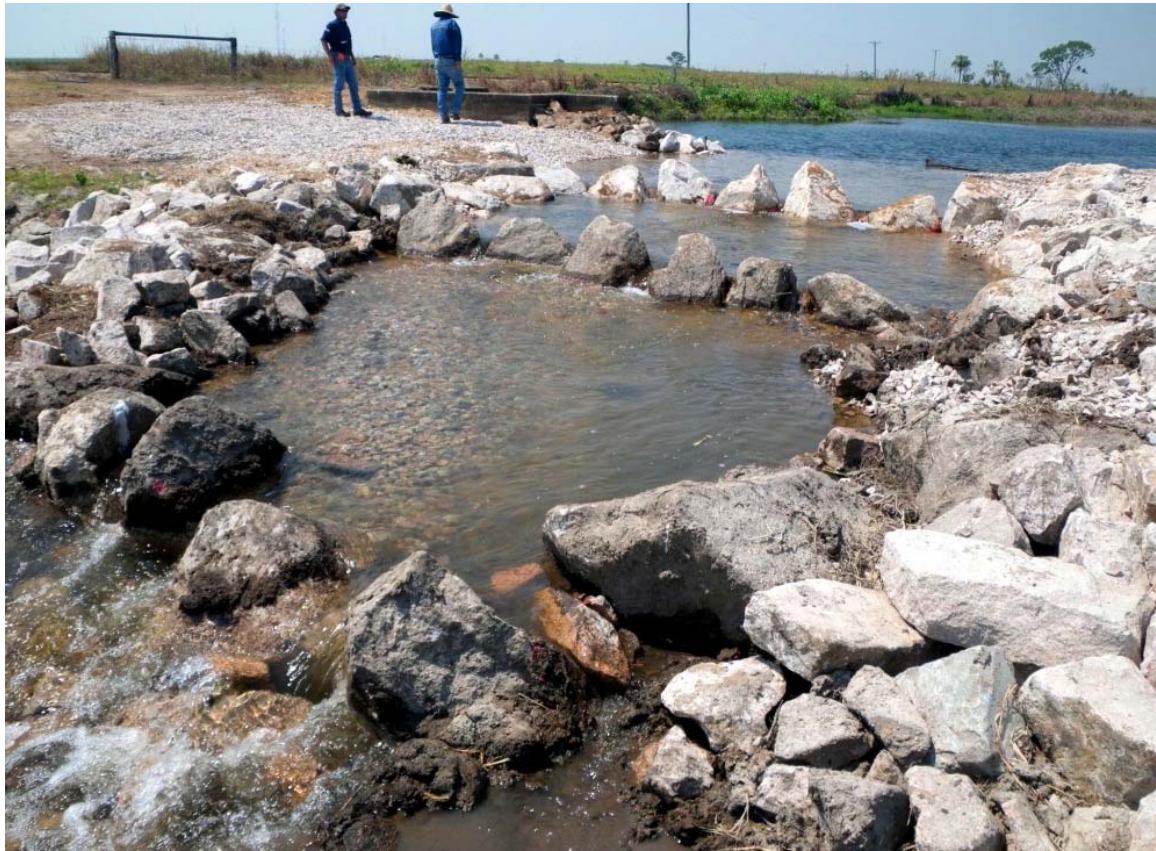
Figure 10. Rock-ramp fishway completed and working under 'normal' flow conditions (photo taken at fishway entrance)

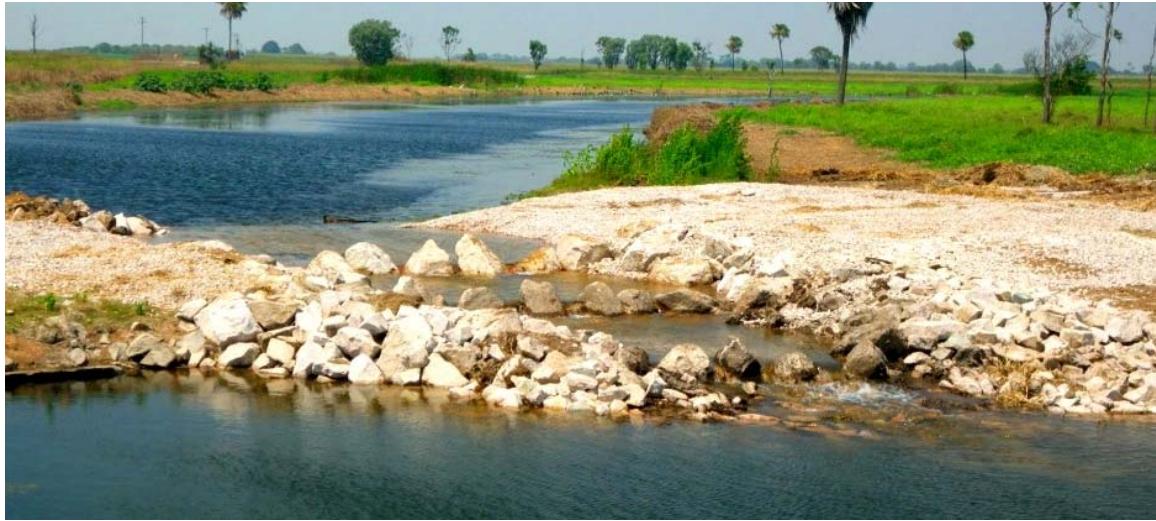
Figure 11. Completed fishway under normal flow conditions.

Note: The tailwater level in this photo is lower than normal, because the irrigation flow down Sheepstation Creek had only just been diverted down this part of the system. One day after this photo was taken; the tailwater level had increased, bringing the water level right up to the entrance of the fishway.

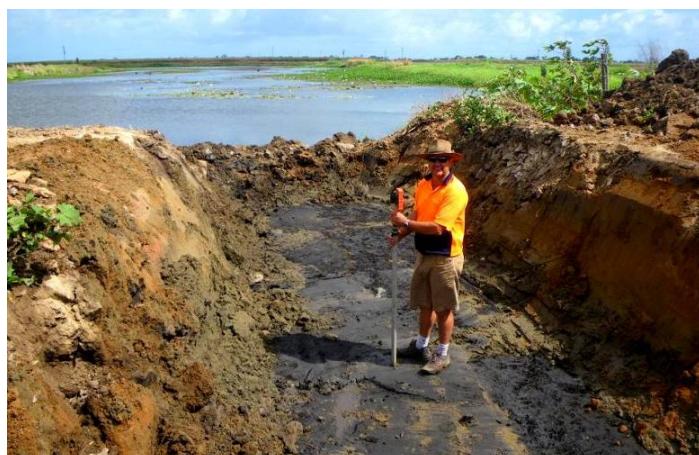
Figure 12. Tim Marsden checking the levels in preparation for the corrugated pipes.

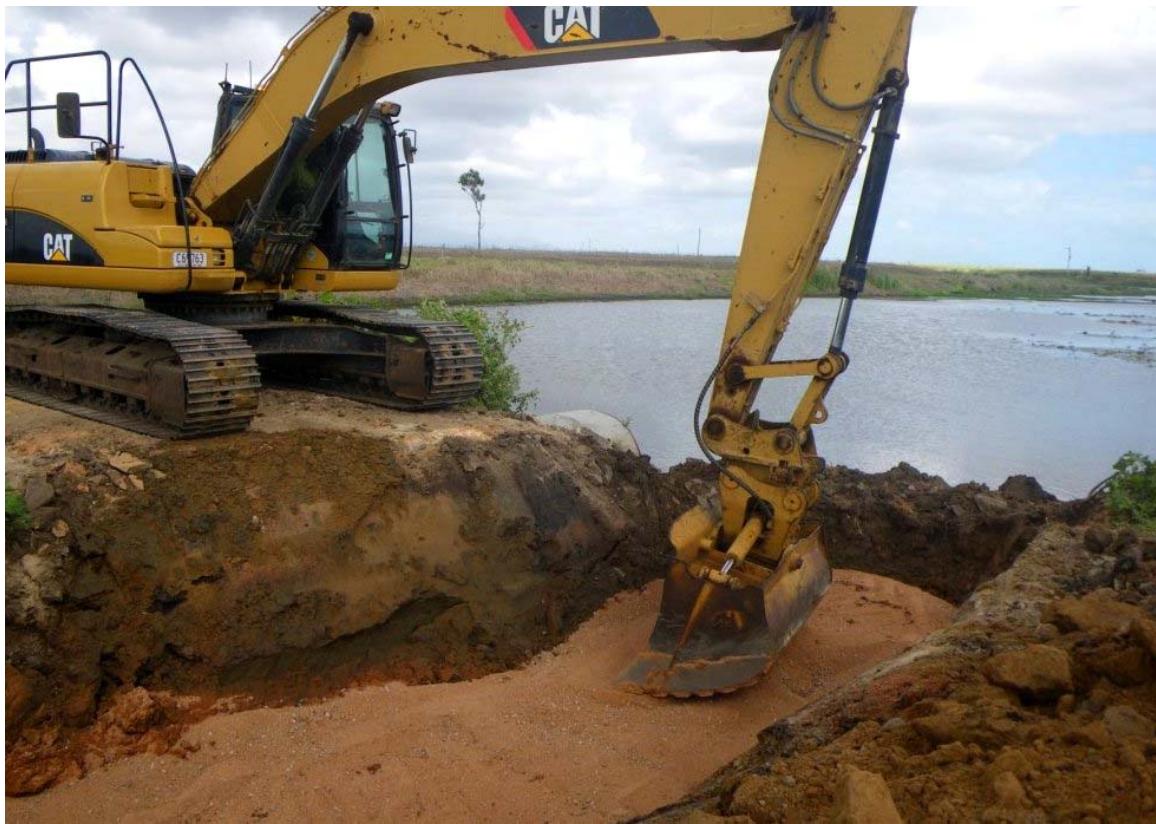
Figure 13. Excavator levelling the road base in preparation for the pipes.

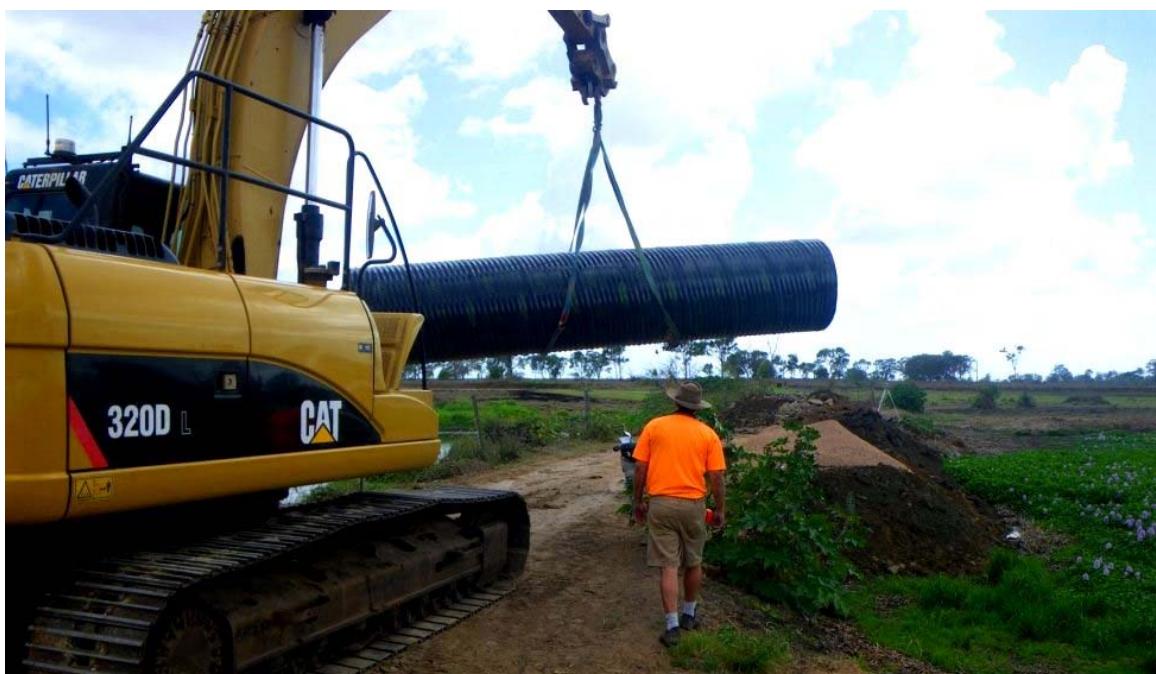
Figure 14. Excavator lifting the pipes prior to placing them into position.

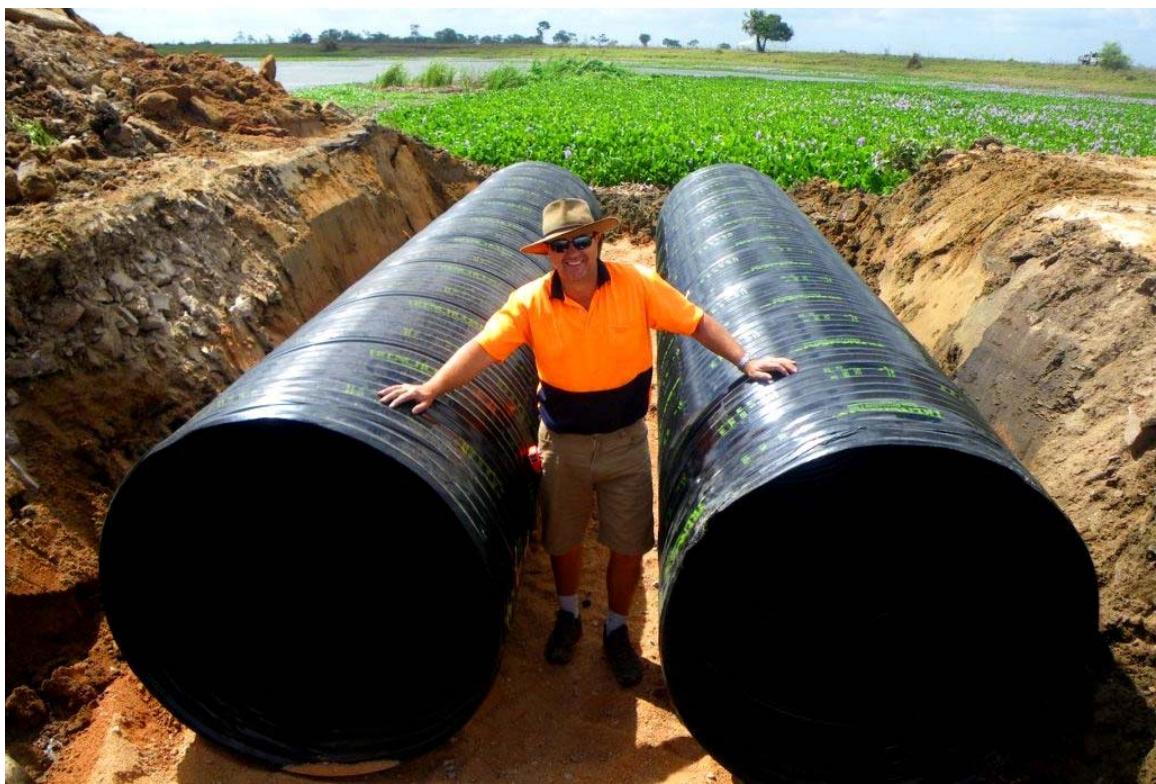
Figure 15. Pipes set at the correct level prior to the excavator filling around them with road base to secure them into position.

Bar1115 located on the east branch of lower Sheepstation Creek (Rob Wills property) was remediated with a fishway that differed slightly from the concept design in the 'Burdekin Fishway's Summary Report 2010-11'. The original design consisted of installing 1500 mm x 1500 mm box culverts. However after further discussions and on site assessments it was decided that the configuration should change. The new designed fishway was constructed out of two 1200 mm (diameter) x 1.6 mm x 5000 mm (length) corrugated galvanised spiral tubing (pipes).

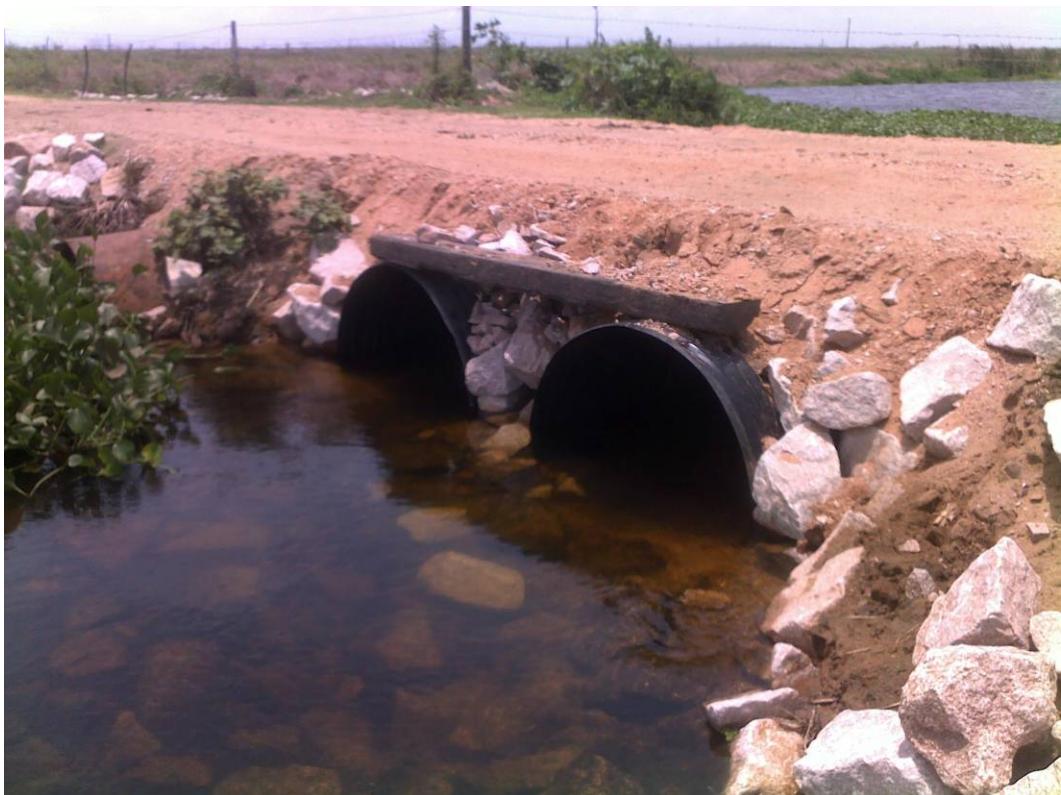
Figure 16. Completed corrugated pipe fishway with rock armouring to secure the pipes into position. Photo taken from upstream.

The corrugations in the pipes are extremely beneficial for fish passage as they disrupt the flow of water, creating low energy resting areas for juvenile fish species. The corrugations also reduce the velocity of water passing through the pipes providing easier access for upstream passage for all fish species likely to be encountered at this site. In addition to this the corrugated pipes provided a substantial cost saving to the project. Rock armouring at the base of the downstream side of the pipes to prevent scouring below the river bed and undercutting the pipes remained as per original concept design. For full fishway designs please refer to pages 35-37 in appendix 1 of this report.

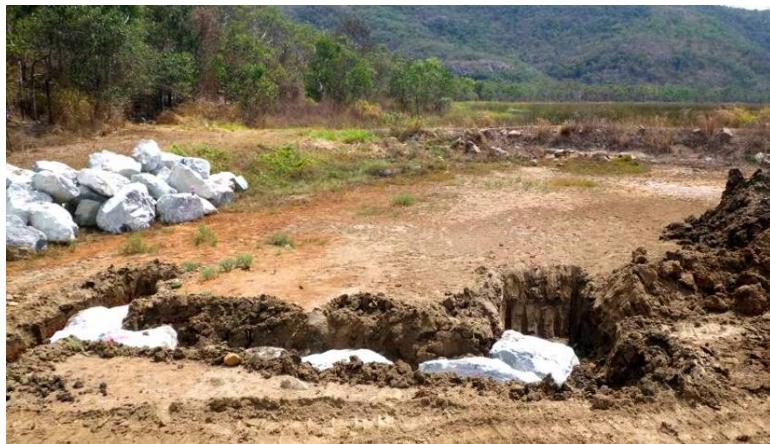
Figure 16. Large 1.2 m sized rock used to form the 'toe' of the fishway.

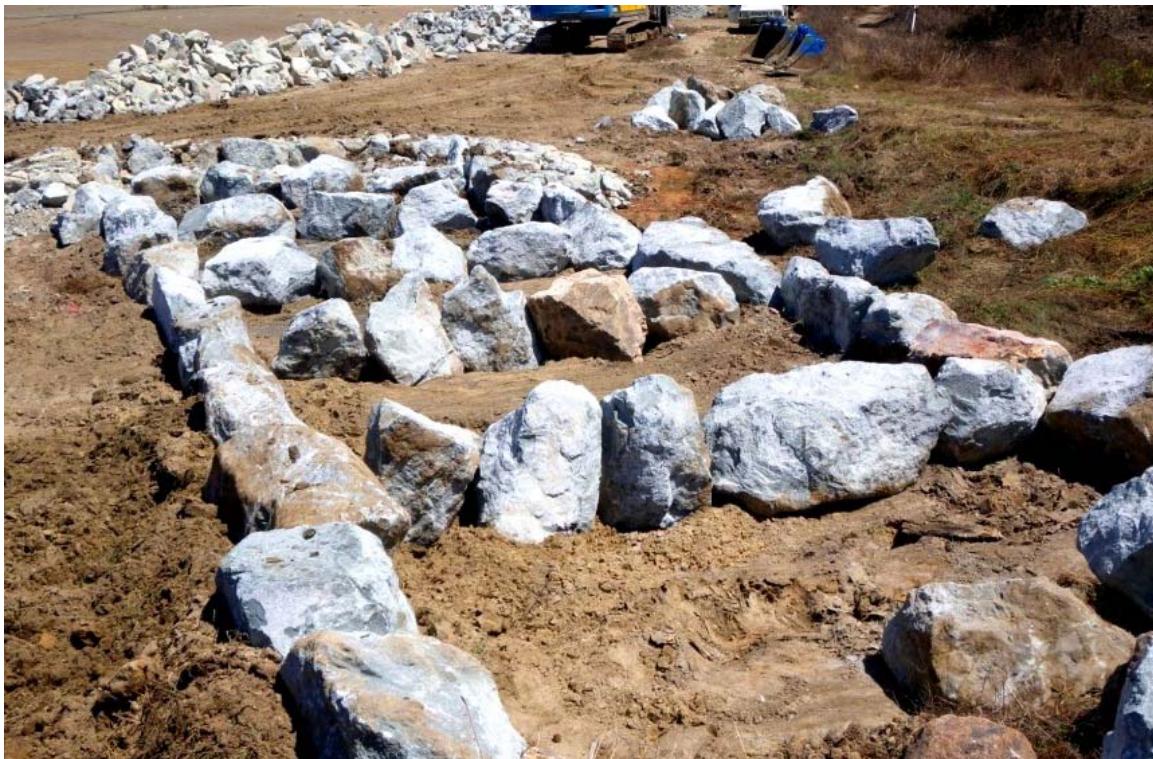
Figure 17. Ridges and side walls of fishway in position.

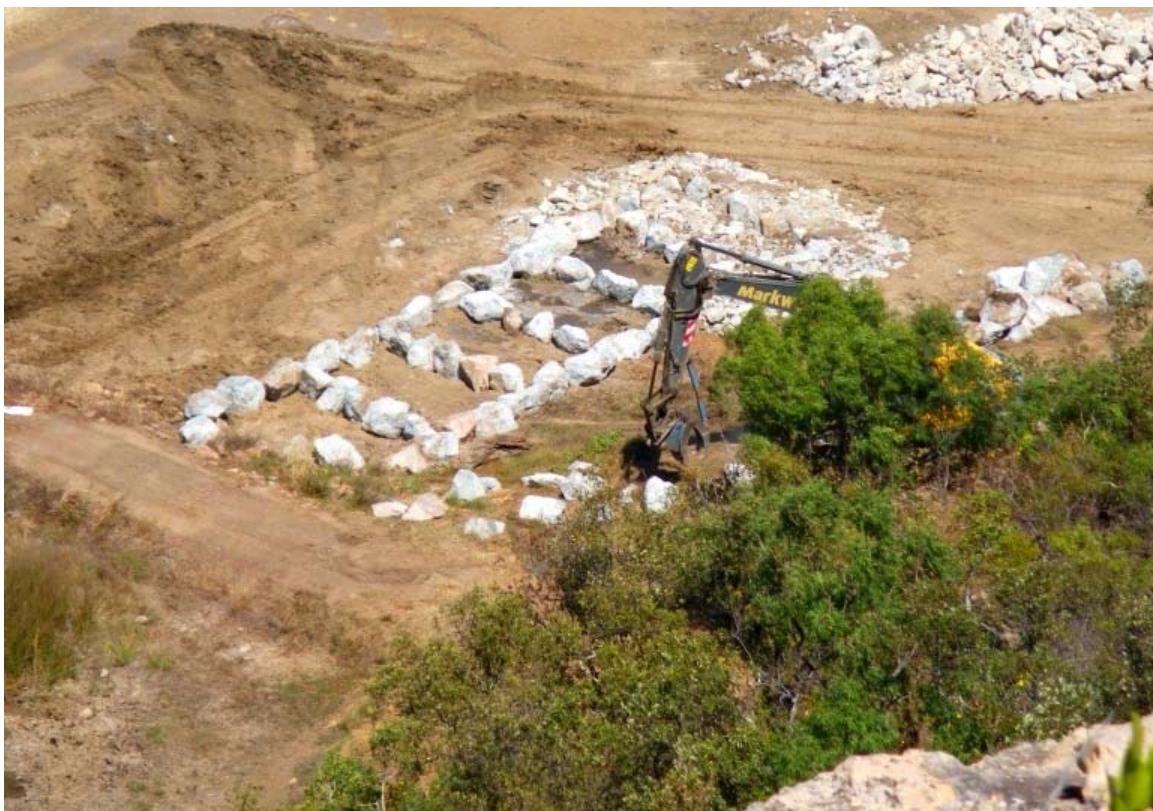
Figure 18. Aerial view of fishway showing the entrance pool completed with rock fill in the bottom.

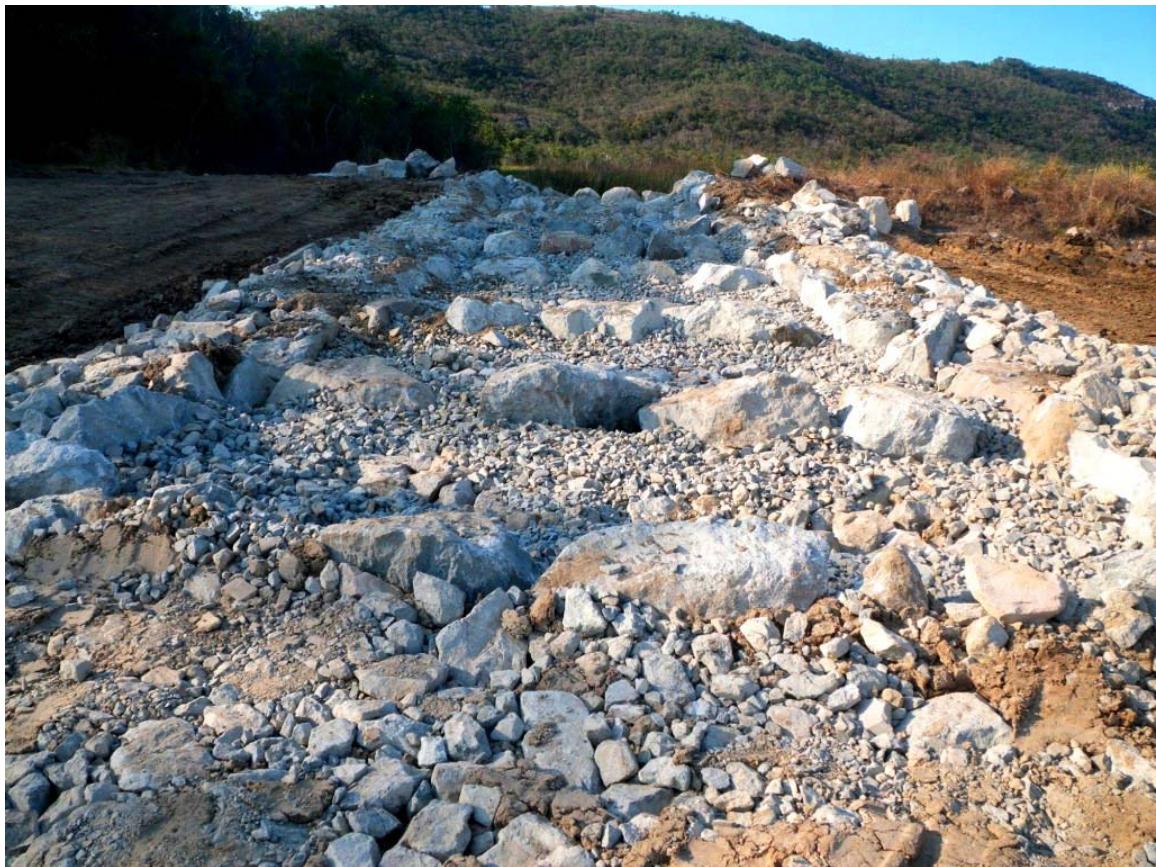
Figure 19. Completed rock-ramp fishway. Photo taken standing at the entrance to the fishway.

To remedy this, the control level of the rock-ramp fishway was constructed slightly lower than the two spillways located on the bund wall, providing initial attraction flows down the fishway. Attraction flows simply draw in migrating fish that are seeking a point within a waterway in which to facilitate their upstream movement. There were no more alterations to the configuration of either the rock ramp fishway or the culverts downstream of the wetland as per the concept design. For full fishway designs please refer to pages 24-27 in appendix 1 of this report.

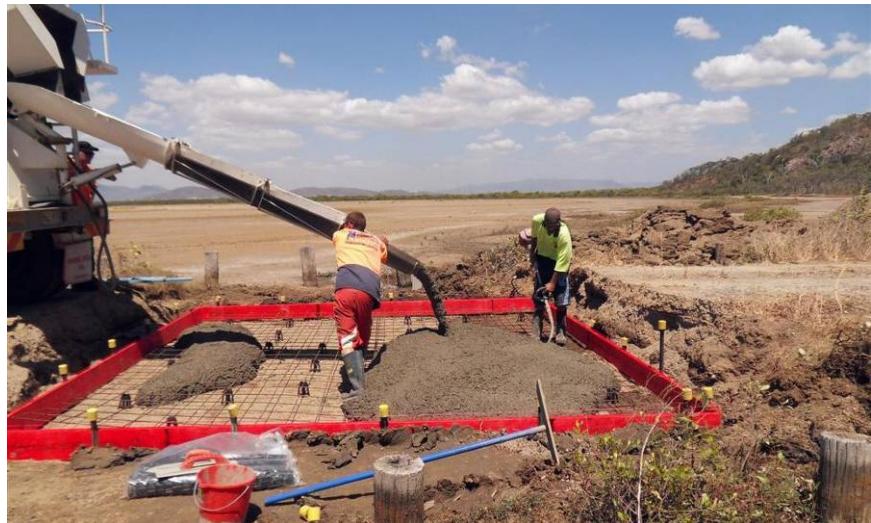
Figure 21. Pouring the base slab for the culverts to sit on.

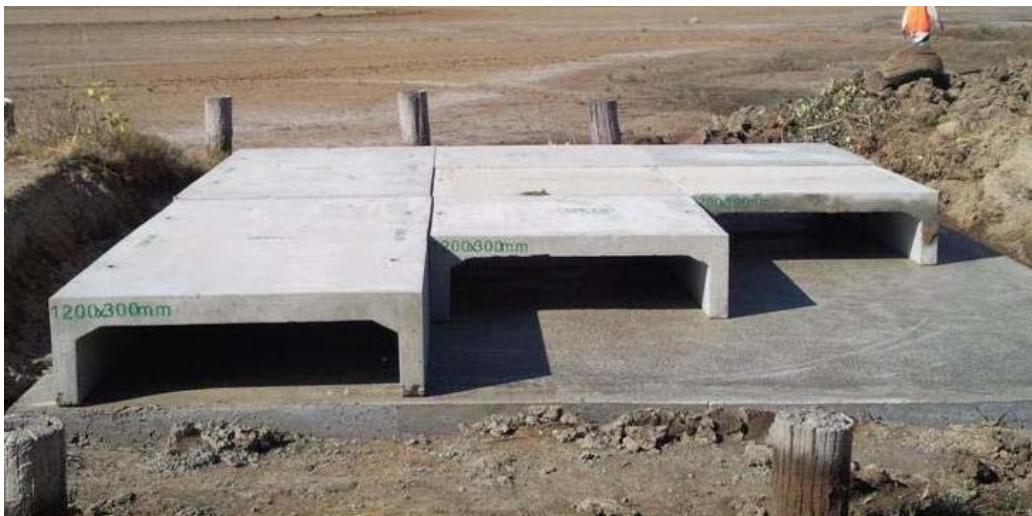
Figure 22. Nine of the twelve culverts in position.

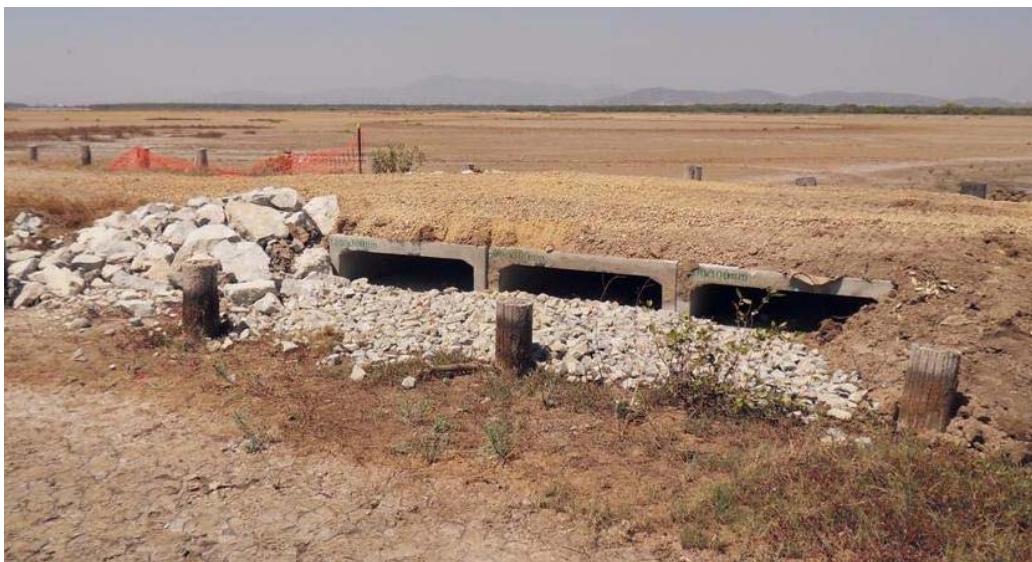
Figure 23. Culverts into position, rock armoured and completed.

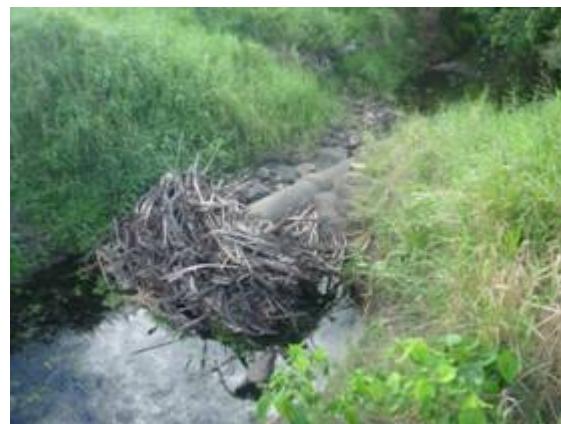
Figure 21. Pipe located on Ironbark Creek.

The old pipe (BAR1114) located on Ironbark Creek (Shirbourne Road, Giru) was completely removed to provide 100% fish passage transparency. This particular barrier was not initially selected as a barrier requiring remediation in the 'Burdekin Fishway's Summary Report 2010-11'.

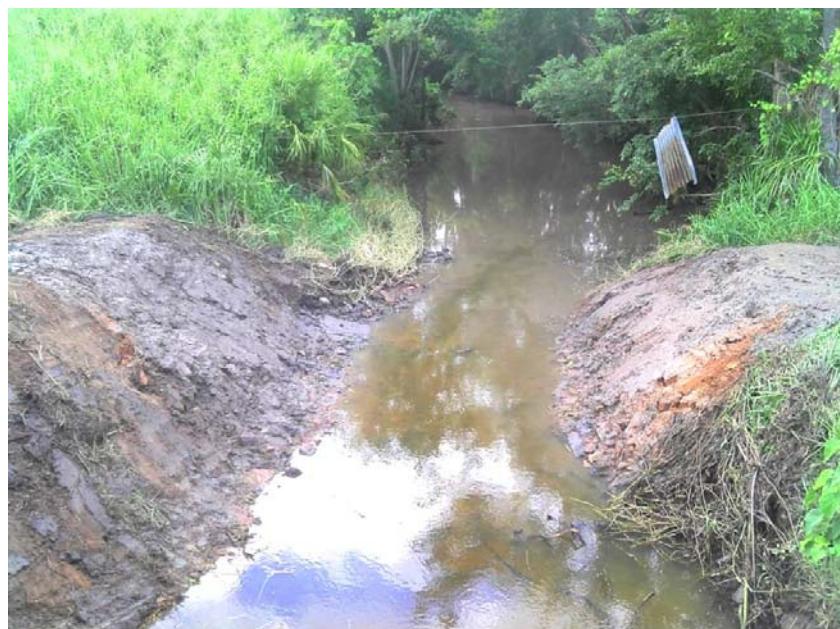
Figure 22. Pipe removed and fish passage restored on Ironbark Creek.

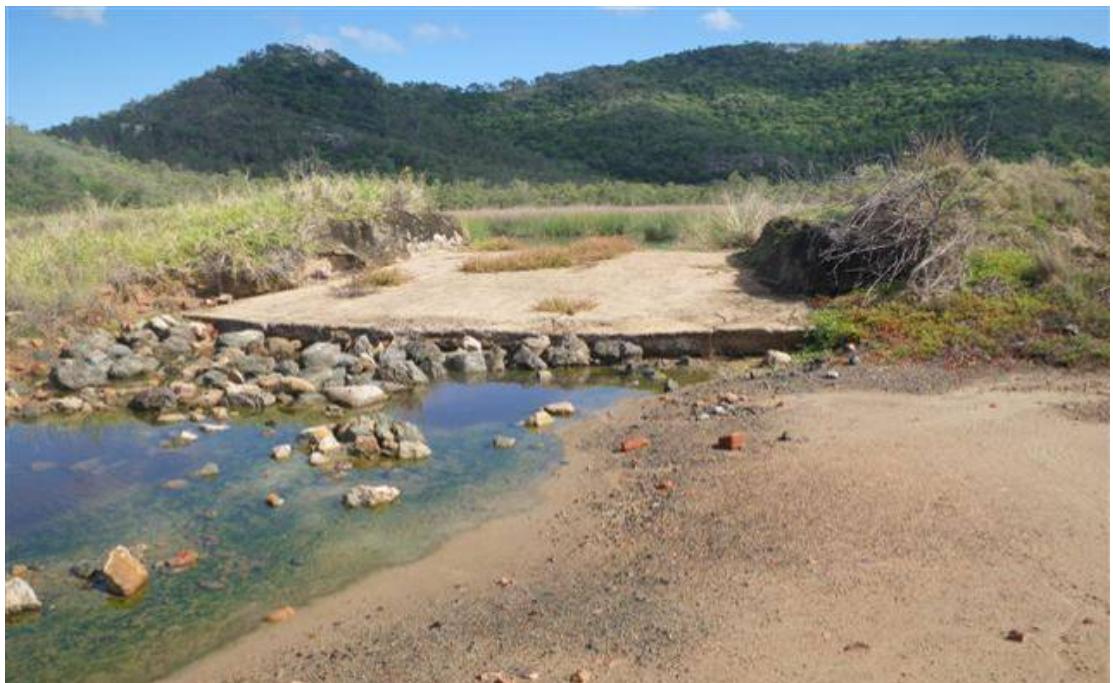
Human influences have had a major impact on this environment with walking tracks & bunds creating distinctive fresh/salt zones. They have been designed to allow freshwaters to flow away from the area whilst excluding salt waters from penetrating into the upstream habitats. This has created a barrier for migratory fish wanting to move out of the salt and into the fresh on low and medium flows. Figure 2 shows the bund that has created a barrier for fish passage into the fresh. Figure 3 shows the small pipes that cause fast velocities too great for fish to negotiate.

Figure 2 - Bund causing a barrier to fish migration between fresh and salt water areas.

In the bund wall that separates the salt from the freshwaters a rock ramp fishway will be constructed at the very end of the bund to allow for vehicles and machinery access. This will be approximately 24 meters long with 9 ridges throughout. A 400mm high concrete wall will be constructed across the existing spillway to maximise water flowing through the fishway.

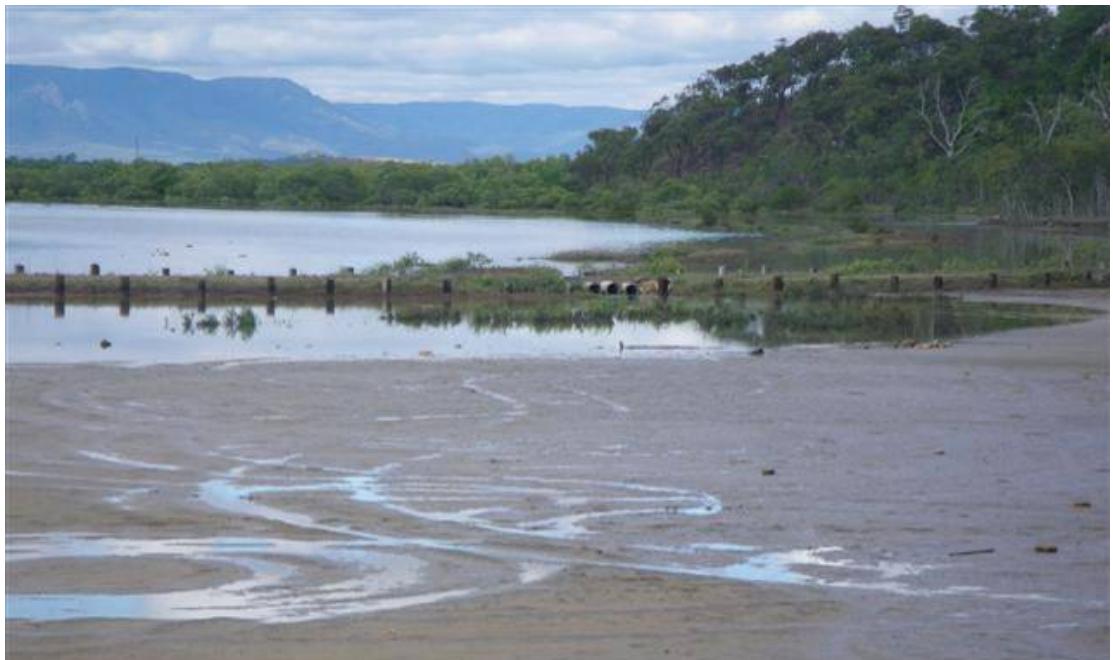
Figure 3 - Roadway with pipes to allow salt water through but not allowing fish passage

To rectify the issue of fish passage, a series of culverts barrels will be installed where the pipes in figure 2 are currently located. These culverts will be 1200mmx300mm and be set out as three culverts wide and four long (see design chapter for details). This solution will allow the roadway to be maintained whilst opening up the site to allow more water through the culverts, and slowing down velocities. These culverts will be rock arched to reduce scouring along the edges.

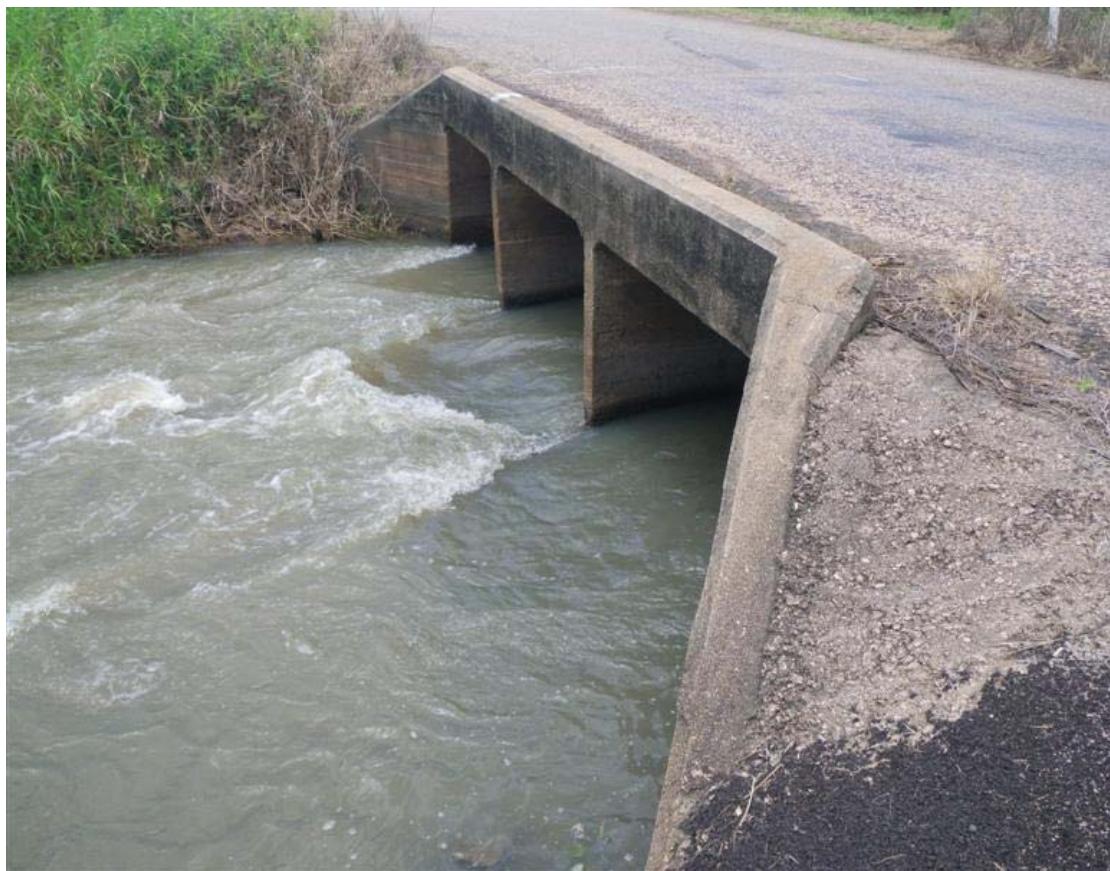
The Five Ways road crossing barrier is located 5.5km south west of Brandon. This part of the Sheep Station Creek system has been significantly impacted upon by the modification of the channel to cater for the increased irrigation water. The three culverts across the creek (figure 6), allow fast velocities, which in turn do not allow for fish passage.

Figure 5 - Upper Sheep Station Creek irrigation channel culvert crossing

Aluminium baffles to be installed on the outside culvert barrels, set at 600mm apart, at the last meter the baffles will be set at 300mm apart on the upstream side. Rock armouring on the downstream side will be dug into the bed to prevent scouring at the base of the culverts.

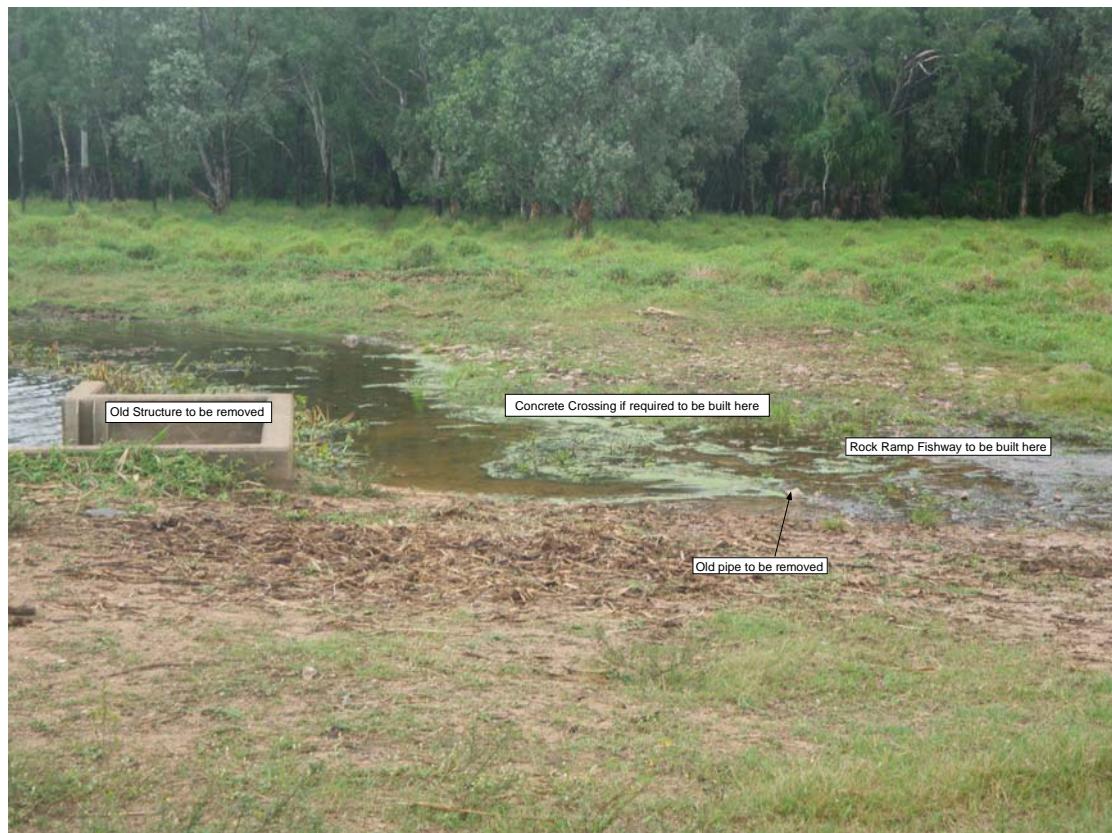
Figure 8. The existing structure at Sheepstation Creek to be removed and a rock ramp fishway to be built.

The old outlet works are to be removed allowing all flow to pass over a full width rock ramp fishway to be installed immediately downstream of the existing outlet works

location. This will be 7.5 meters long by 12 meters wide with 4 ridges. If required by land holders a concrete crossing can be also be installed.
