Moore's Creek Fishway Sampling Report

March 2013

Matthew Moore & Tim Marsden

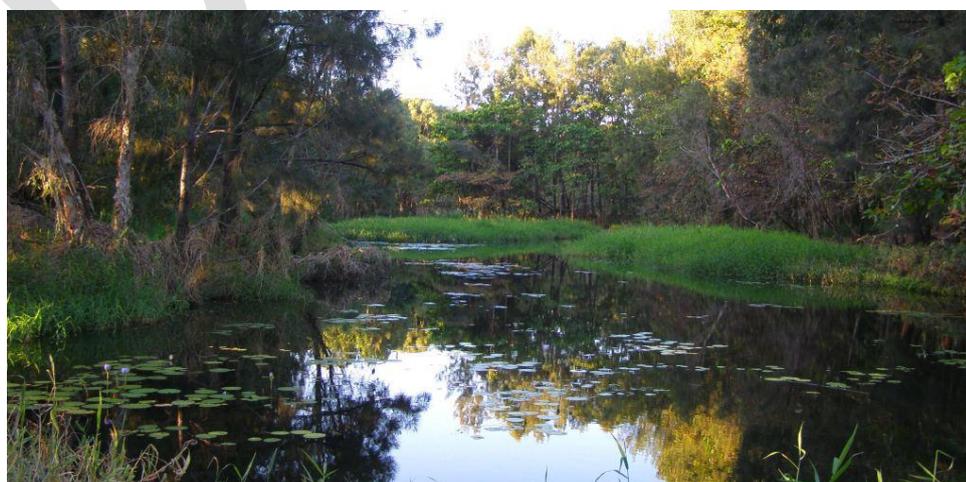
Figure 5. Moores Creek middle reach habitat.

The middle reaches of Moores Creek extend for approximately 7 km's and are heavily impacted by urban areas. Overall, riparian habitat condition is generally poor, with only some small sections of Moores Creek containing riparian habitat in moderate condition. Stream substrate is dominated by small pebbles and gravel, with moderate amounts of in-stream habitat and aquatic macrophyte coverage. This section contains some deep pools offering important refuge areas for fish and other aquatic animals during the dry season. Overall, middle reach fish habitat is suitable for a wide range of both adult and juvenile diadromous and potamodromous species. A moderate barrier to fish passage in the form of an 800 mm high concrete weir is located under Musgrave Street, and separates the middle and lower reaches. The Barrier is located approximately 1.4 kms upstream from the pipe culvert causeway (fishway location), and has formed a permanent pool directly upstream, creating good fish habitat.

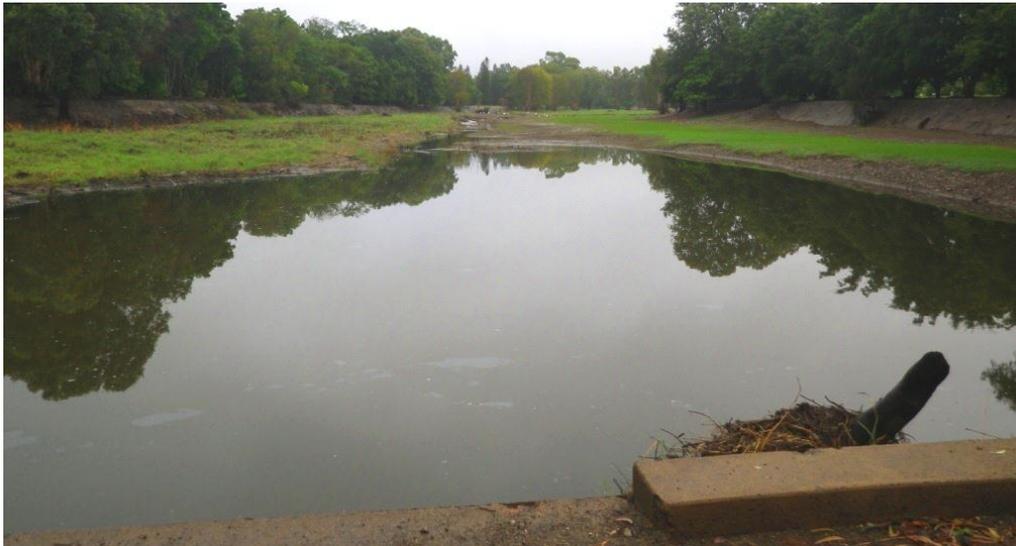
Lower reaches of Moores Creek are heavily impacted by surrounding land use practices dominated by urban residential dwellings. Water quality in these stream reaches deteriorates significantly when compared to upper reaches. Surprisingly for an urban waterway, riparian habitat is in moderate condition in some stream reaches but very poor in other areas. A 1.1 m high pipe culvert causeway is located on the freshwater/estuarine interface of Moores Creek. The causeway has caused the accumulation of sediments to build up in the weir pool directly upstream. The sediment deposits have significantly reduced the water level in the weir pool, creating a shallow degraded urban landscape void of in-stream fish habitat (Figure 6).

Figure 6. Shallow, degraded pool upstream of the causeway on lower Moores Creek.

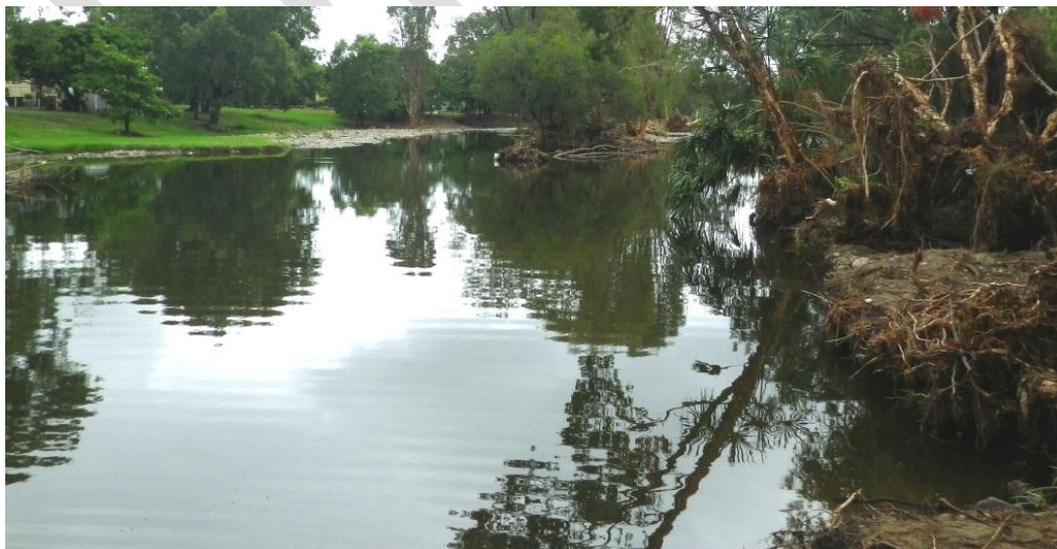
Figure 7. Lower reach permanent dry season refuge habitat.

Lower stream reach habitat upstream from the weir pool improves dramatically, with some large pools offering good in-stream habitat in the form of woody debris and aquatic macrophytes. These stream reaches offer good habitat for juvenile and adult diadromous and potamodromous fish species and suitable refuge habitat during the dry season (Figure 7).

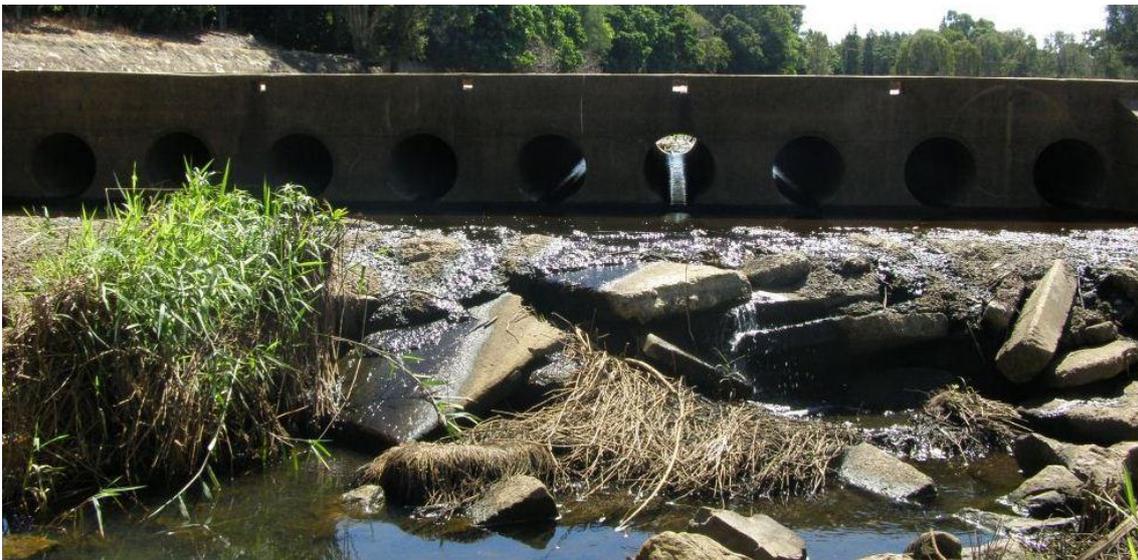
Figure 9. Moore's Creek pipe culvert causeway (Charles Street).

The Moore's Creek causeway is located on the freshwater/estuarine interface, and is the location for the Moore's Creek partial width rock ramp fishway (Figure 10). Moore's Creek causeway is a 60 m long by 10 m wide concrete pipe culvert structure. The causeway rises 1.1 m high above bed level on the downstream side. The causeway is influenced by high tides around the full and new moon periods, which are capable of reducing the barrier's height to approximately 600 mm. Located on Charles Street in the middle of Rockhampton, it was built to provide vehicle and pedestrian access across Moore's Creek. This structure was a low transparency barrier, preventing connectivity during medium and low flow events. For information regarding the Moore's Creek Fishway, please read the 'Moore's Creek Fishway Construction Report'.

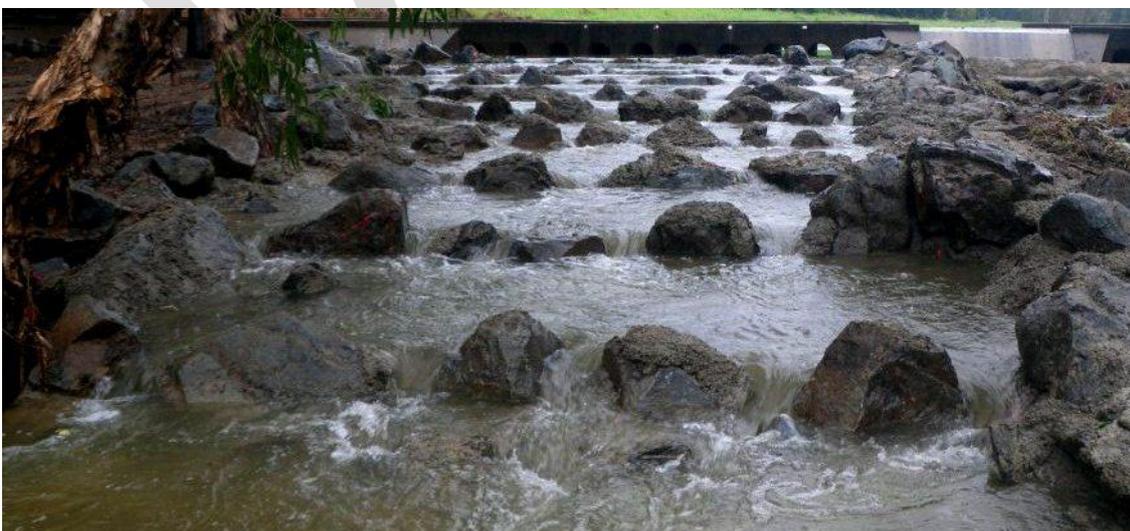
Figure 10. Newly constructed (July 2011) nature like partial-width rock ramp fishway

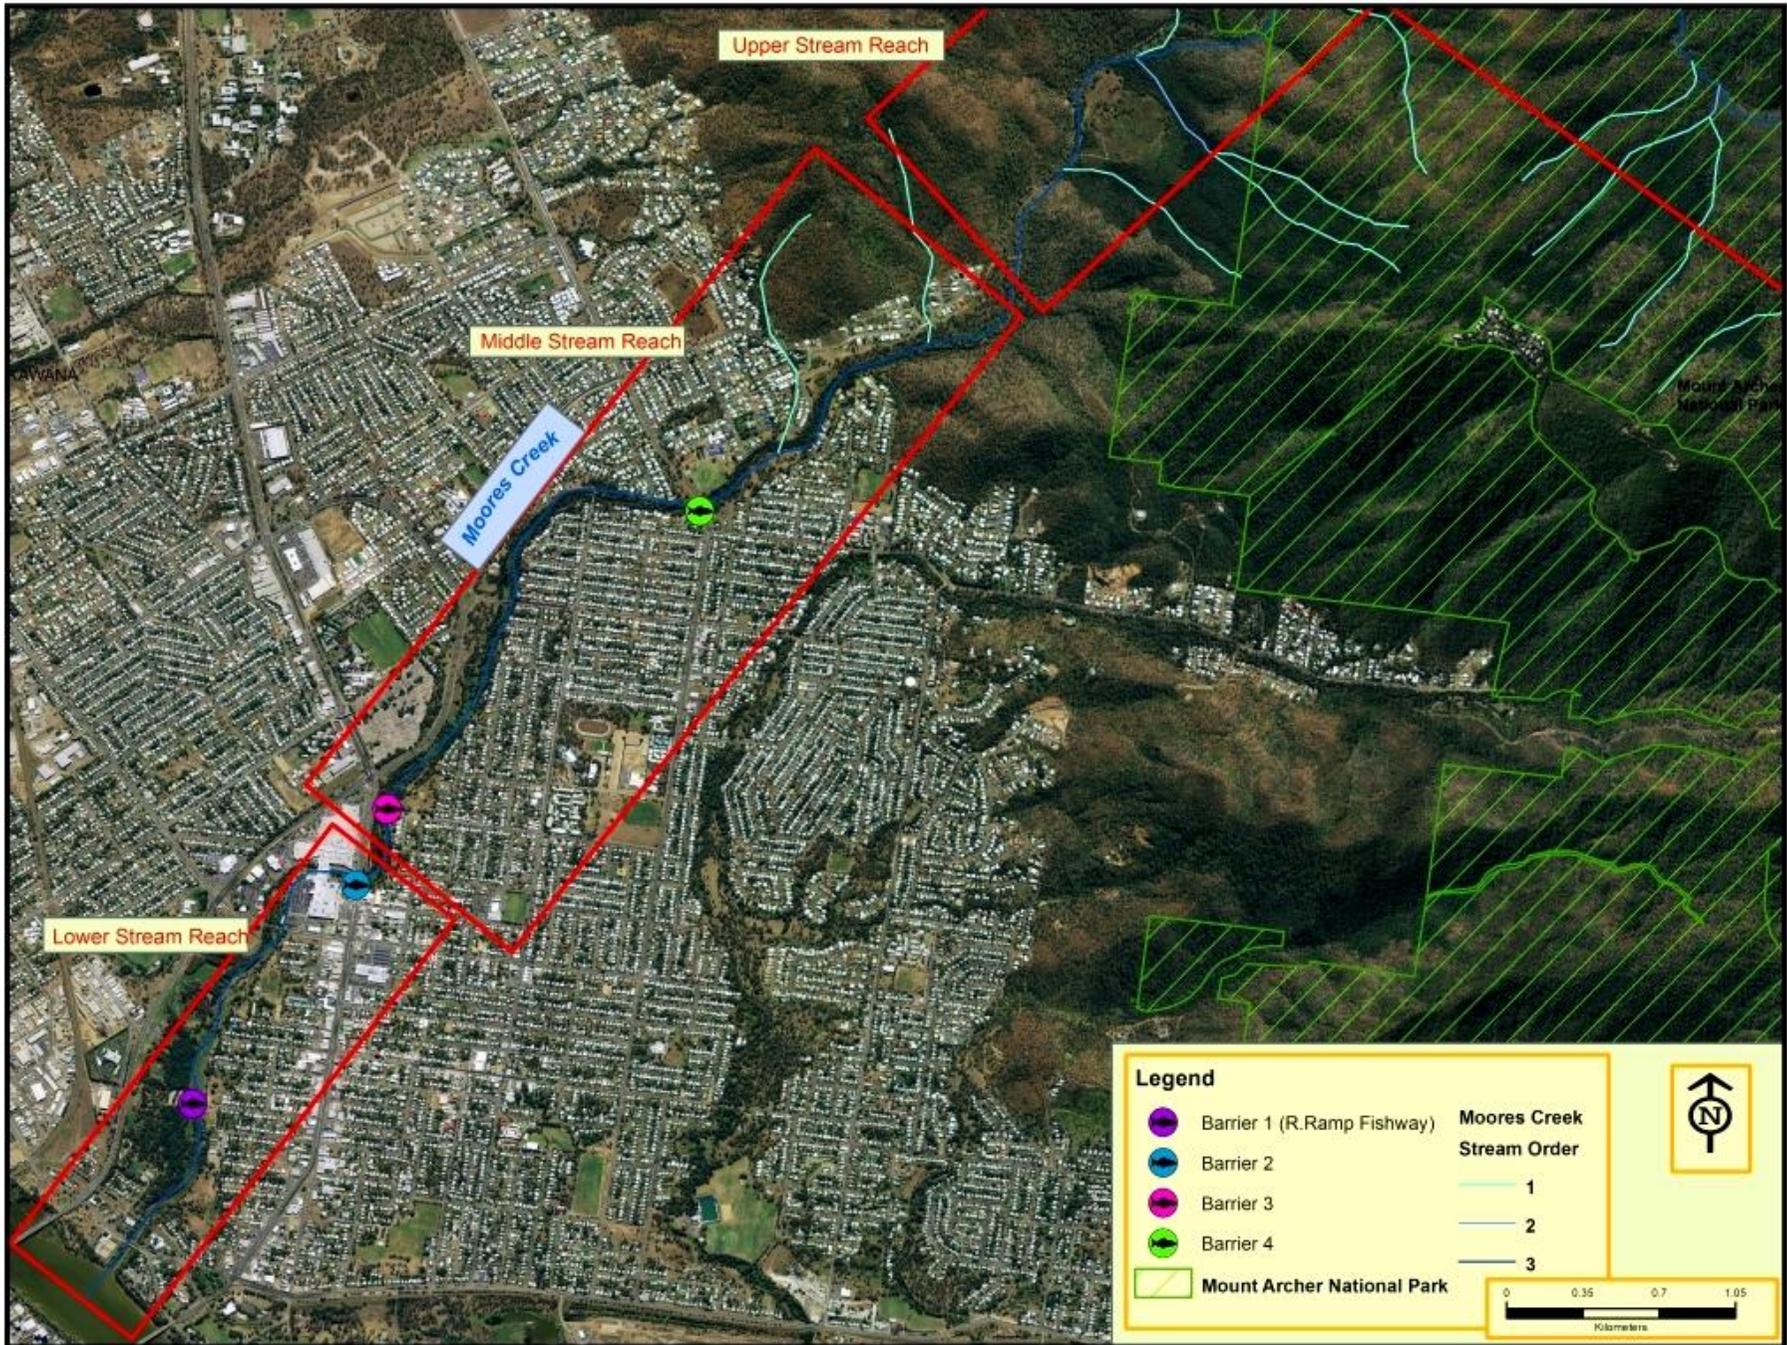
There are currently four barriers to fish passage located on Moore's Creek (Figure 8). The first and most restrictive barrier was a pipe culvert causeway (Figure 9) located on Charles Street (this barrier has been negated due to the construction of a partial width rock ramp fishway). The adopted middle thread distance (amtd) is approximately 1 km. According to the Australian Bureau of Meteorology (n.d), the amtd is the distance in kilometres, measured along the middle of a watercourse that a specific point in the watercourse is from the watercourse's mouth or junction.

Figure 8. Location of barriers to fish passage on Moores Creek. Note barrier 1 has been remediated with a partial-width rock ramp fishway

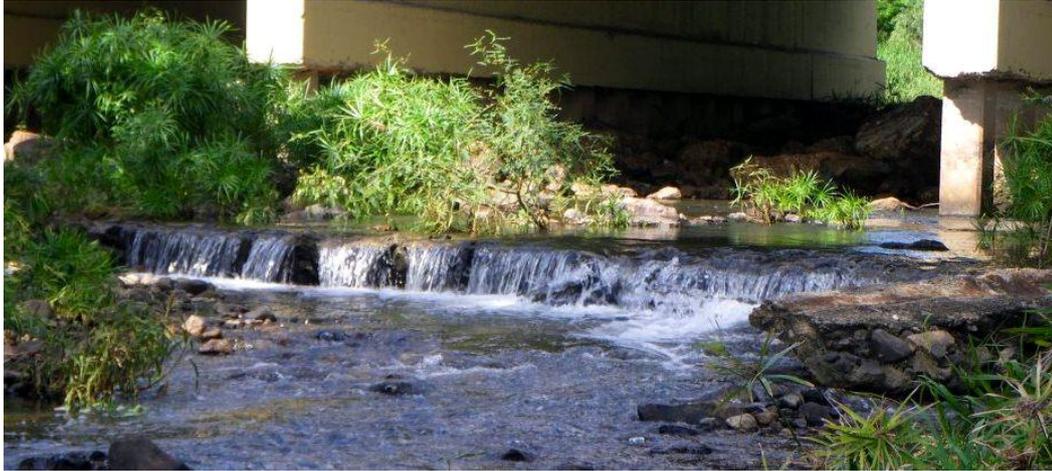
Barrier 2 is located underneath the Musgrave street bridge, a mtd 2.5 km's. Two small structures, together forming an approximate 700 mm barrier. The first small barrier has formed due to substrate being eroded away on the downstream side of a concrete apron constructed as part of the overall bridge structure. This small barrier is approximately 200 mm high (Figure 11). This drop on the downstream side of the apron is a barrier to fish passage only during low flow conditions.

Figure 11. Small barrier to fish passage on the downstream side of the concrete apron.

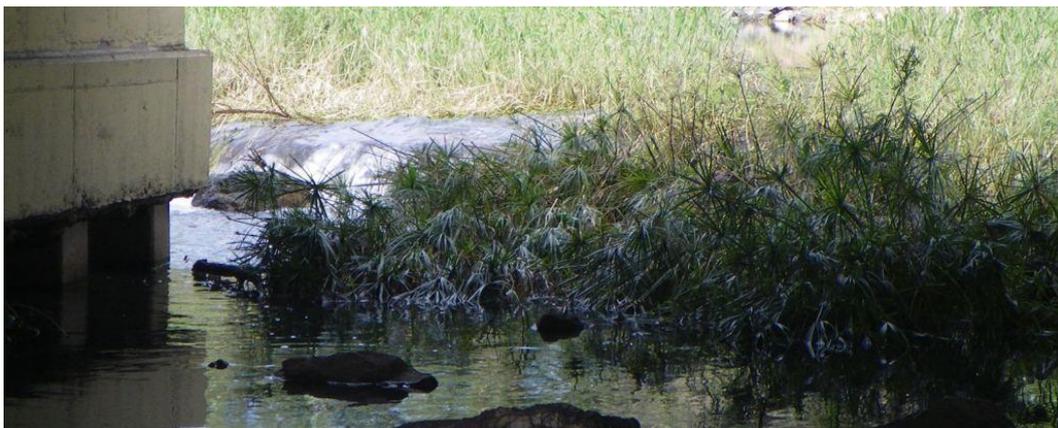
The second and larger barrier consists of a small concrete weir on the upstream side of the bridge (Figure 12). This barrier is approximately 500 mm high. The weir is a barrier to fish passage during most medium flow and all low flow conditions. Some fish passage for some species and size classes would be permitted on high and moderate flows. However, due to the small catchment size of Moores Creek and its geographic position in a low rainfall region, moderate and high flow conditions only occur over a limited amount of days each year. If fish species are not ready to migrate when these conditions occur, then passage would not be facilitated. However, low flow conditions persist for months on end, and if a fishway was constructed, it would allow connectivity between lower and middle reaches for thousands of diadromous and potamodromous fish.

Figure 12. Small barrier to fish passage on the upstream side of the bridge.

Although there are some upstream river reaches in good condition, the majority of lower and middle reaches are in poor condition. Remediation works to create additional aquatic habitat by increasing the depth of pools, planting riparian habitat and the addition of in-stream woody debris in these reaches is recommended. This is particularly pertinent directly upstream of the fishway, where sediment has deposited, in-filling the waterhole and decreasing the amount and quality of available habitat. It is recommended that the deposited sediment in this section is removed. This would provide additional dry season refuge habitat in the lowland reaches of Moores Creek. Three barriers to fish passage remain in upstream reaches. These barriers should be remediated to assist connectivity between lowland and upland river reaches. The barrier to fish migration under the Musgrave Street bridge should be the next highest priority in the Moores Creek catchment.

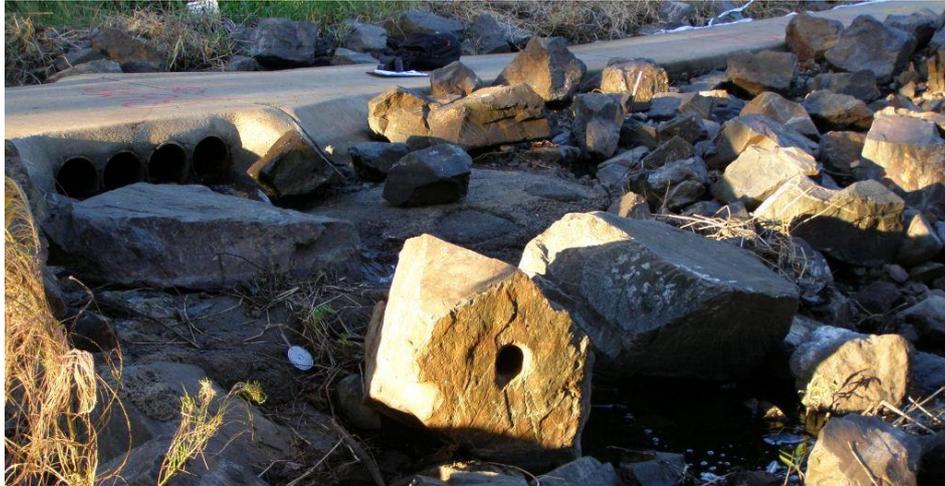
Barrier 3 is located 3.0 km's a mtd. The structure consists of a concrete pipe culvert causeway built to provide pedestrian access across Moores Creek (Figure 13). The structure forms a velocity barrier through the small pipes during some low flow conditions and a water surface drop barrier on some low to medium flows when the water cascades over the structure. This barrier is only a small barrier, and fish would be able to negotiate this structure during most really low flow conditions and throughout most medium and high flows conditions.

Figure 13. Barrier 3, a small concrete pipe culvert causeway.

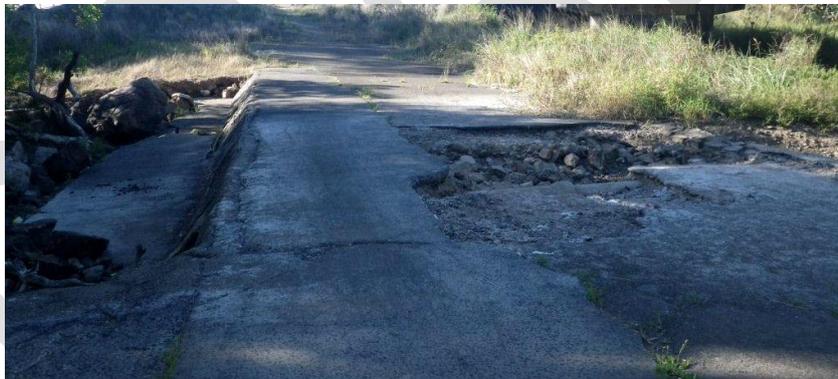
Barrier 4 is located in the middle reaches of Moores Creek on the downstream side of the Norman Road bridge, approximately 5.5 km's amtd. The structure consists of a concrete pipe culvert causeway and associated concrete apron (Figure 14). The extremely old and unused causeway consists of 3 pipes, which are currently clogged by debris (Figure 15). The barrier is approximately 900 mm in total height, consisting of a 200 mm high drop on the downstream side of the concrete apron and a 700 mm high concrete causeway. The causeway is no longer used. It's recommended that the causeway be removed, thus permitting fish passage to the upstream reaches of Moores Creek over most flow conditions.

Figure 14. Barrier 4, a pipe culvert causeway in the upper middle reaches of Moores Creek.

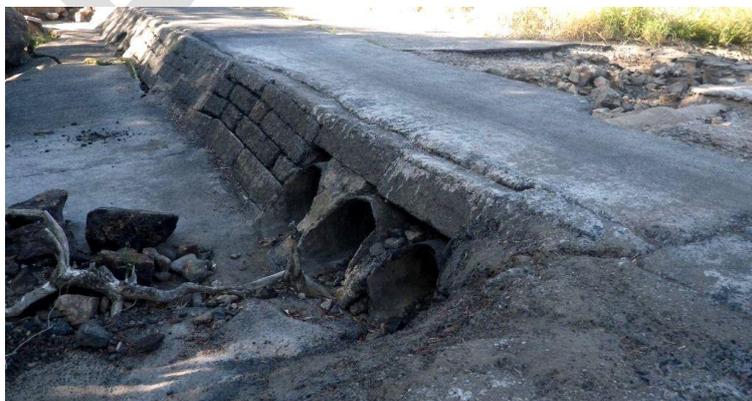
Figure 15. Barrier 4, showing the degraded pipes.

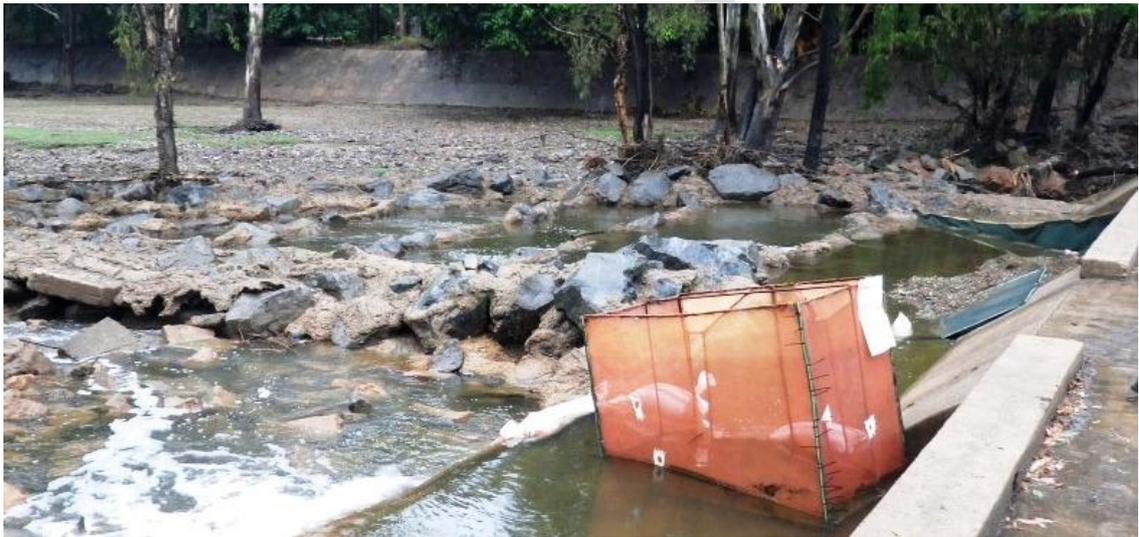
Fishway sampling was conducted to validate the effectiveness of the fishway at passing different fish species and size classes. Fishway sampling consisted of placing a 'fish trap' at the top of the fishway (Figure 16) to record fish species and size classes of fish successfully migrating through the fishway. The trap used for this method was constructed out of 12 mm round bar with shade cloth (4 mm mesh size) covering the frame. One cone shaped entrance was placed into the front of the trap. A wing wall constructed from shade cloth was installed to help guide fish into the trap (Figure 16).

Figure 16. Fishway trap placed above fishway but below pipes. Note the wing wall in the foreground (right hand side) placed in position to help guide fish into the trap.

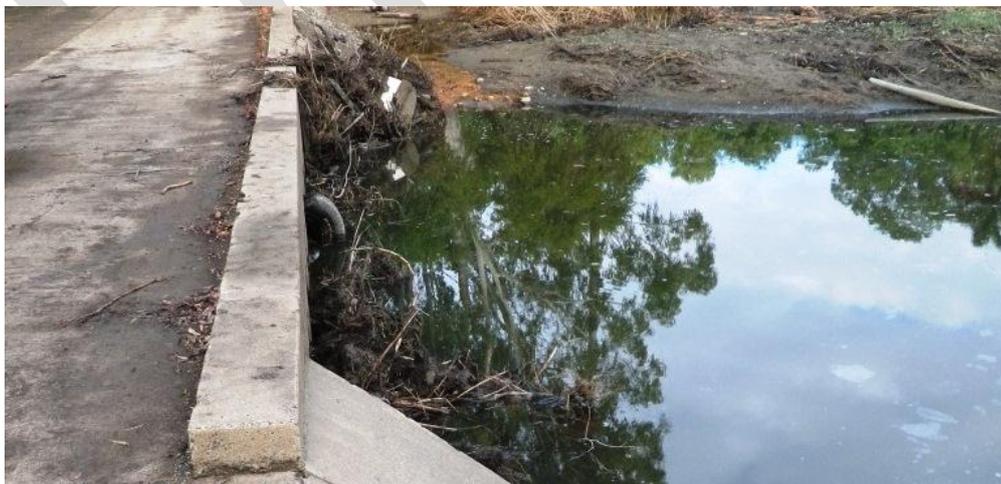
The trap was placed above the fishway, but downstream of the pipes due to large quantities of flood debris blocking the pipes and preventing the trap placement upstream of the pipes (Figure 17).

Figure 17. Large quantities of debris blocking pipes on the upstream side of the causeway.

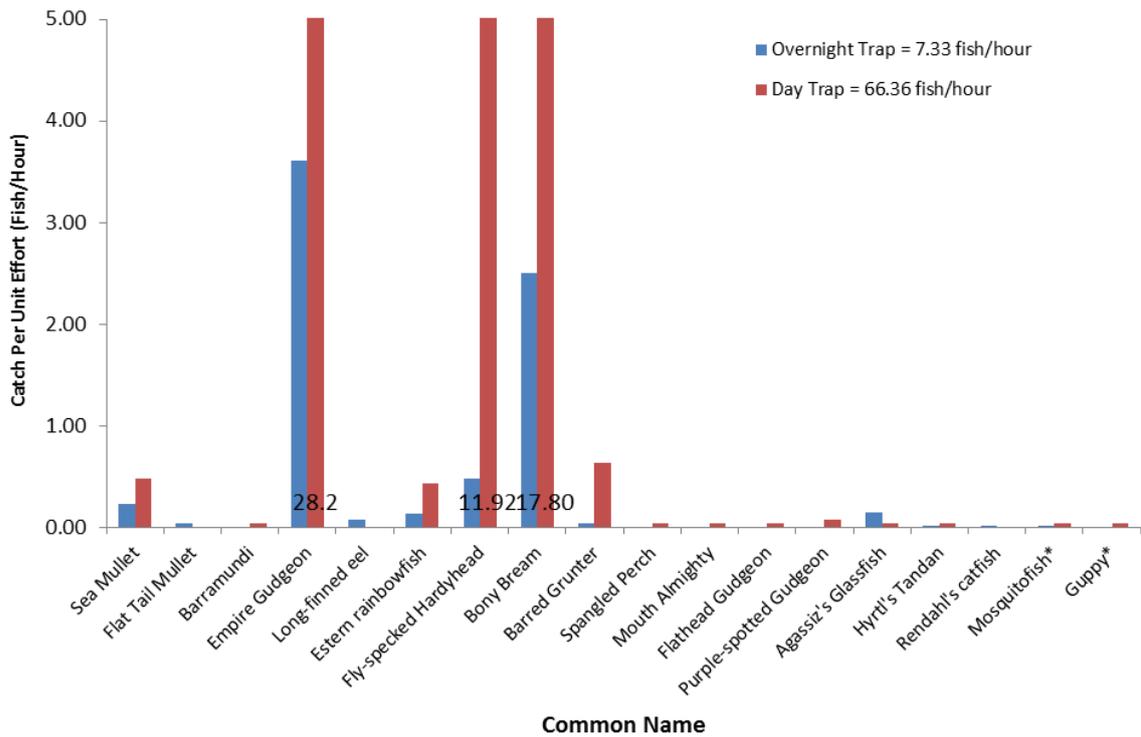
Figure 18. Catch per unit effort of fish recorded during overnight and day fishway trap sampling.

Fishway tap sampling during the day recorded a higher catch per unit effort (66.36 fish/hour) than overnight fishway trap sampling (7.36 fish/hour). Only three species; long-finned eel, rendahl's catfish and agassiz's glassfish were recorded at a greater abundance during overnight trap sampling when compared to day trap sampling (Figure 18).
